Manhole Inspection Summary

Manhole # S47EE_041MH

Insp Date: **7/31/08 9:48 AM**

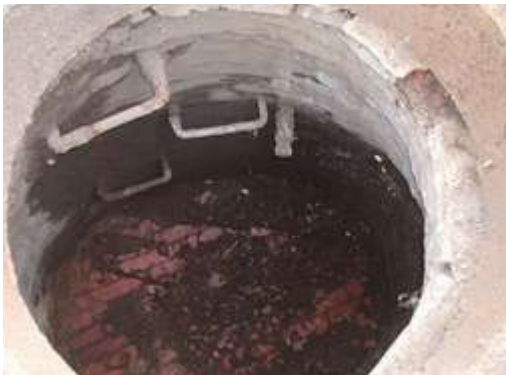
Defect 1

frame leaks

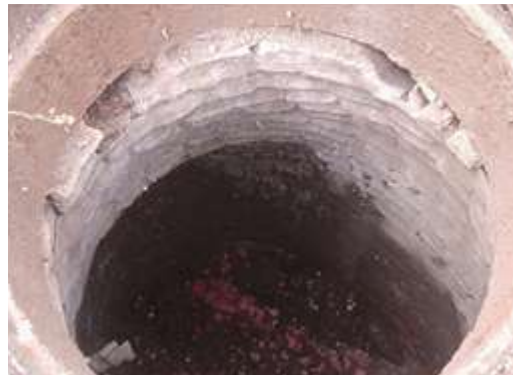
Defect 2

Condition: ☐ Sound ☐ Cracked ☐ Root Intrusion ☒ **Loose Brick** ☐ Deteriorated

Infiltration: ☐ None ☐ Joint ☐ Cracks ☒ **Mortar** ☐ Roots ☐ Wall

loose bricks

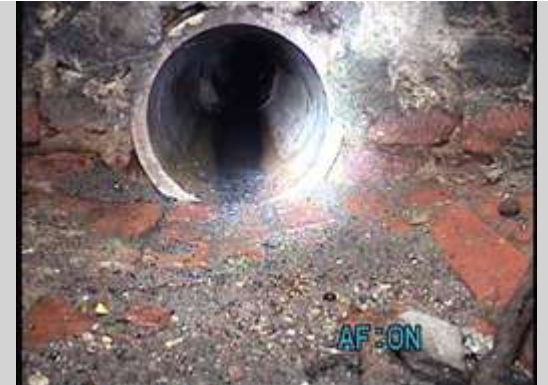
12 O'Clock Outflow

8 in. Circular Gravity Sewer
Pipe Out @ 12 O'Clock

Infiltration: **None** Pipe Seal Cond: **Sound**
